DEP/INLAND WATER RESOURCES DIVISION DAM INSPECTION CHECKLIST

DAM NAME & #: Birch Mill Pond
#5004

INSPECTION DATE: 11/27/07 and 4/29/08

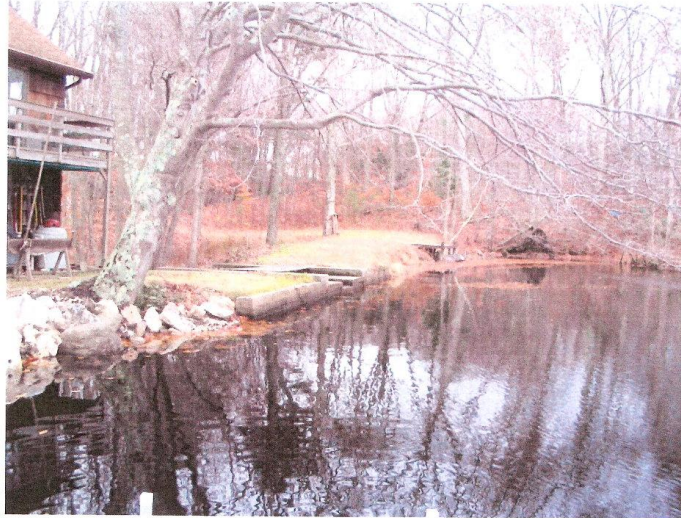
Photo #1: Overall view of the dam from the left dam abutment.

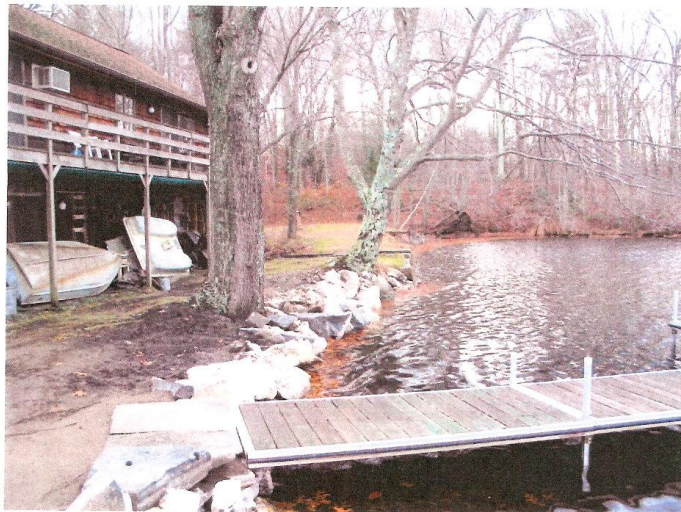
Photo #2: View of the upstream embankment and crest from the left dam abutment.

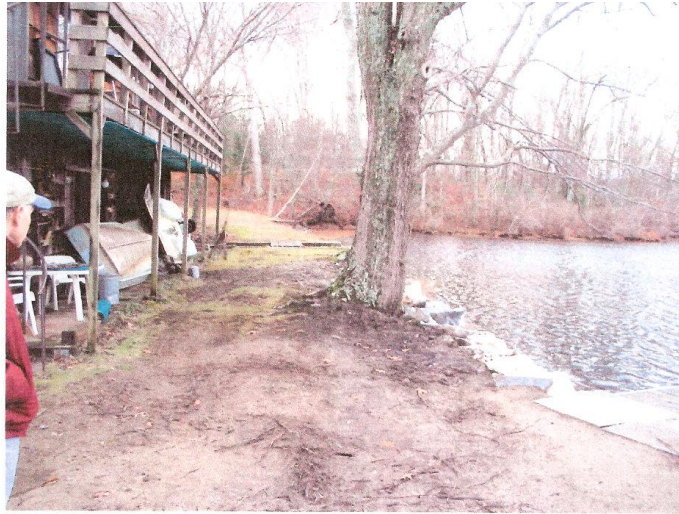
Photo #3: View of the dam crest from the left dam abutment.

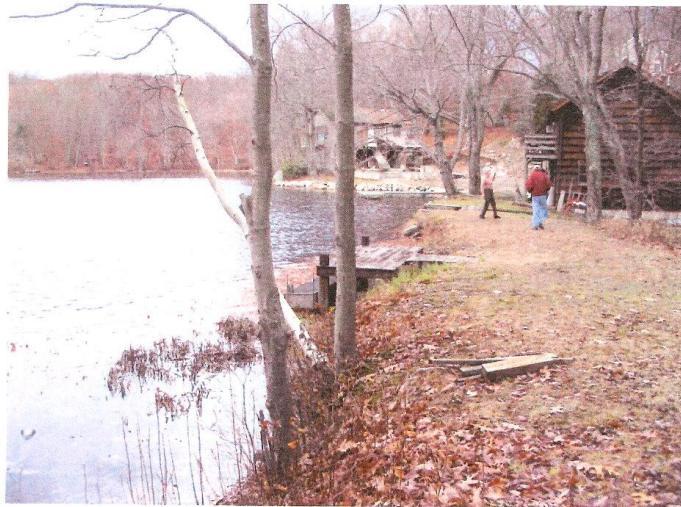
Photo #4: View of the upstream embankment and dam crest from the right dam abutment.

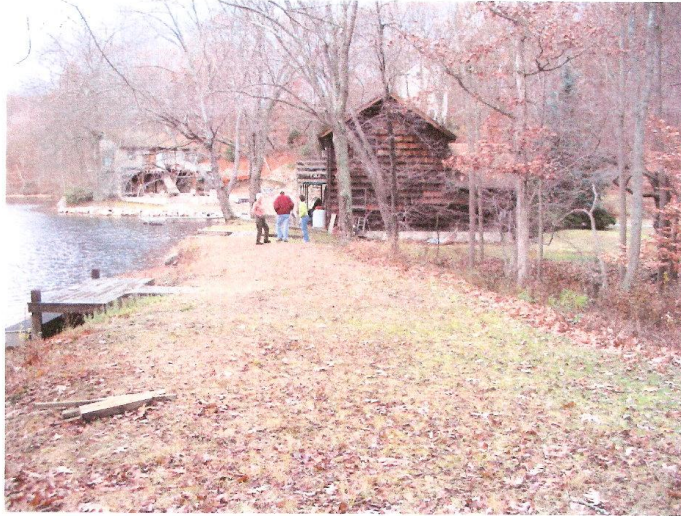
Photo #5: View of the dam crest from the right dam abutment.

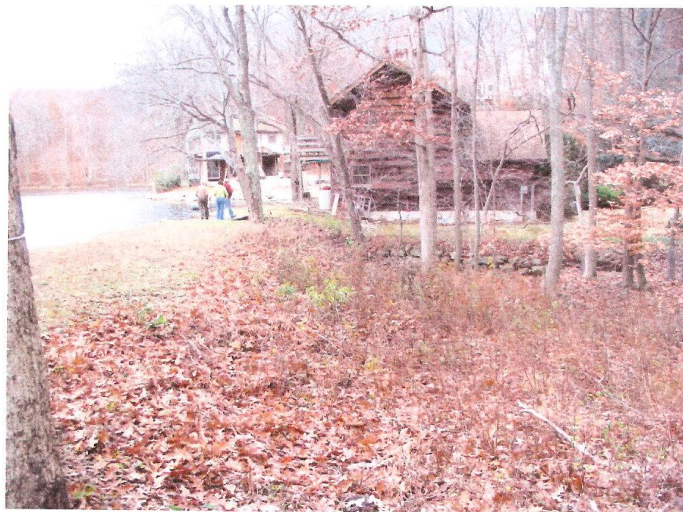
Photo #6: View of the right downstream embankment from the right dam abutment.

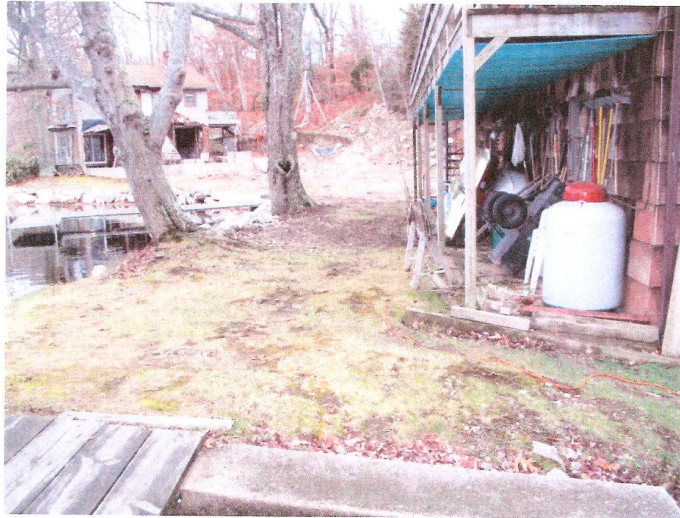
Photo #7: View of the left side dam embankment from the spillway section.

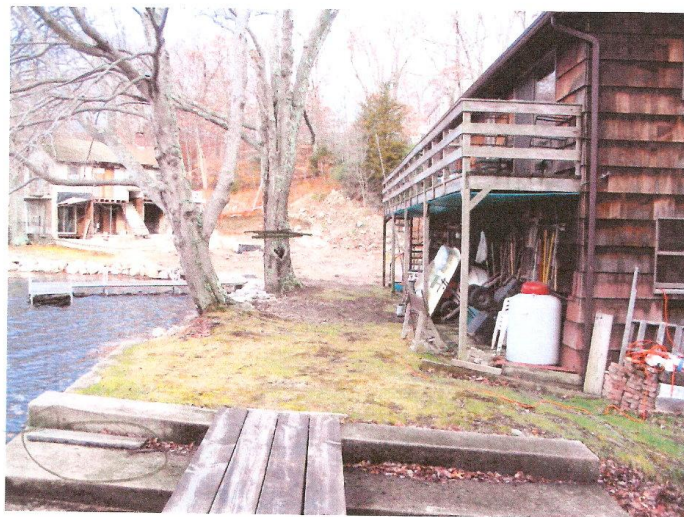
Photo #8: View of the left side of the spillway section and the left side dam embankment from the right spillway training wall.

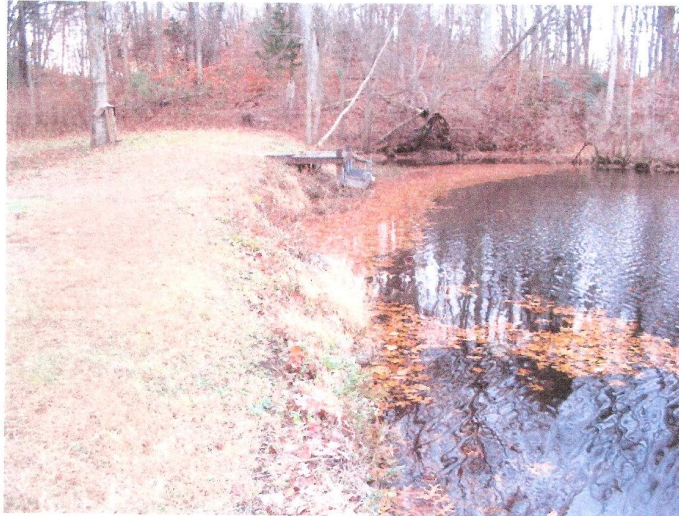
Photo #9: View of the right upstream embankment and dam crest from the spillway section.

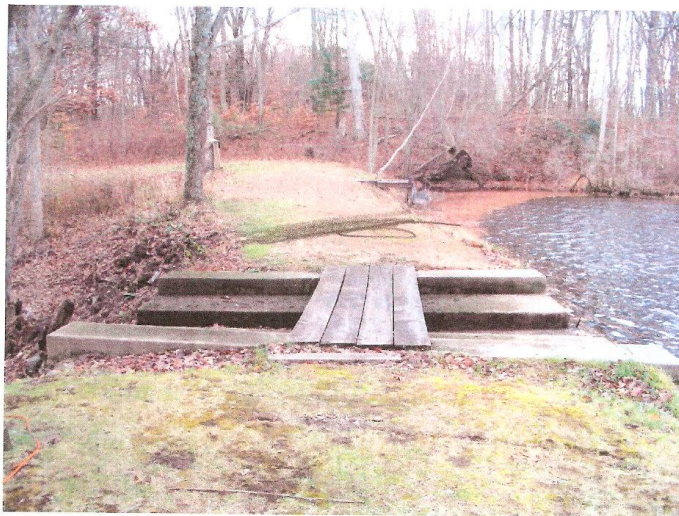
Photo #10: View of the spillway section and right side dam embankment from the left side of the dam.

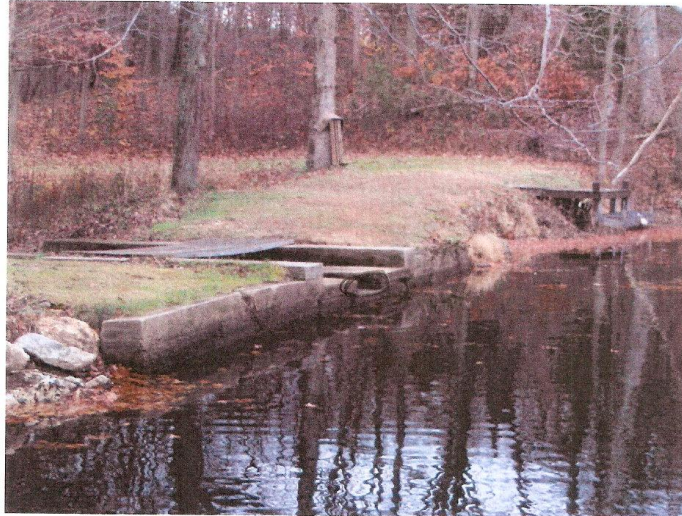
Photo #11: View of the upstream side of the spillway section.

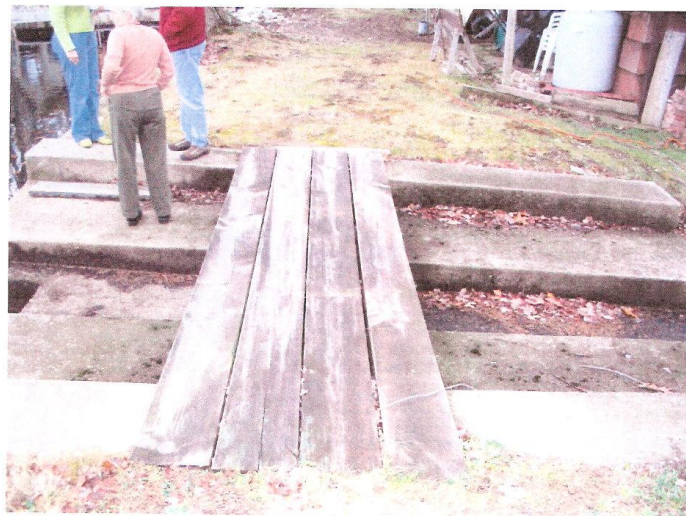
Photo #12: View of the spillway section from the right side dam embankment crest.

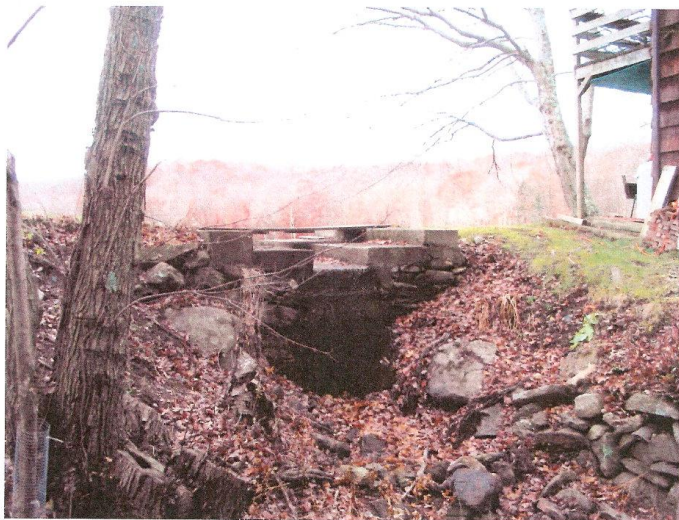
Photo #13: View of the downstream side of the spillway section taken from the downstream channel.

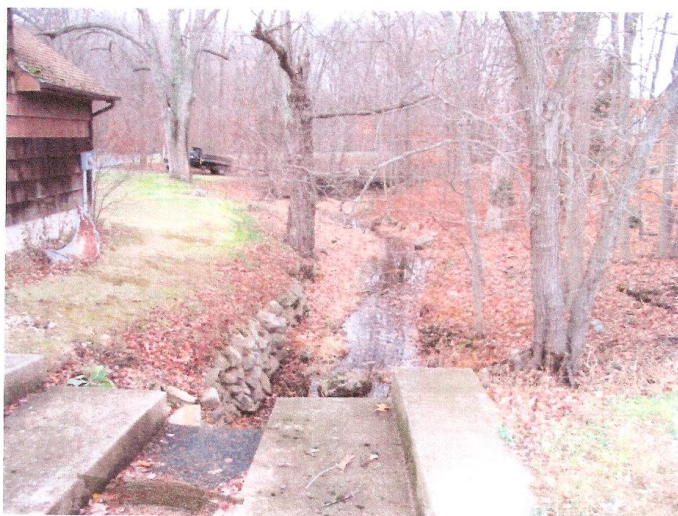
Photo #14: View of the downstream channel area taken from the spillway section.

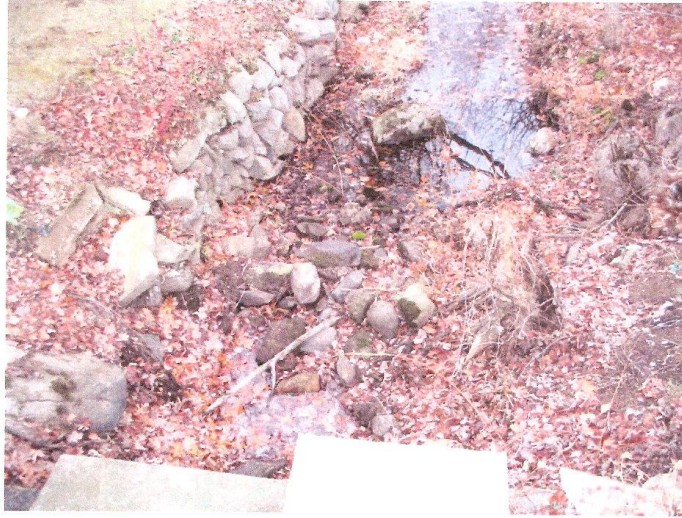
Photo #15: View of the downstream channel area immediately below the spillway section.

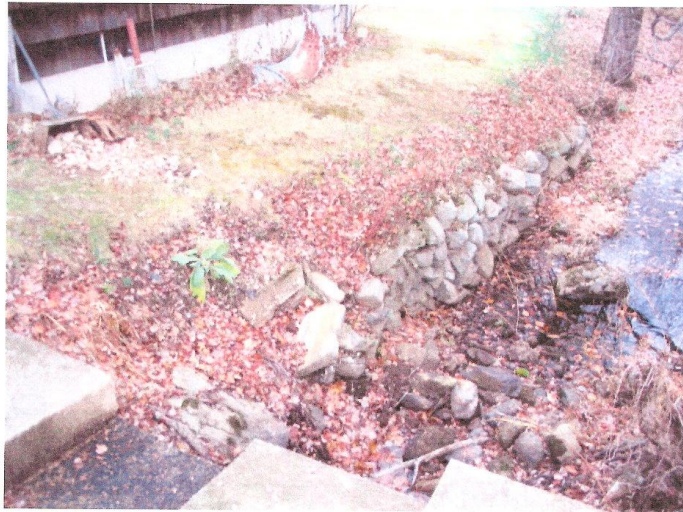
DEBRIS: Some of the left downstream channel wall has collapsed.

Photo #16: View of the left side of the downstream channel directly below the spillway section.

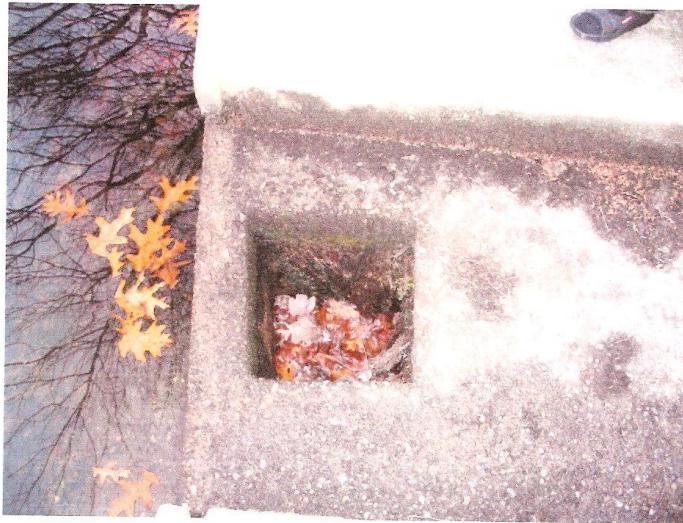
GENERAL CONDITION: The condition of the intake structure is unknown. It is located on the upstream side of the spillway section.

Photo #17: View of the upstream chamber for the intake structure located in the center of the upstream portion of the spillway section.
