## **Dam Inspection Report**

**Birch Mill Pond Dam,  
Essex, CT  
Connecticut Dam Inventory No. 5004**

■ *August 25, 2017*

**Lenard Engineering, Inc.**  
Civil, Environmental & Hydrogeological Consultants

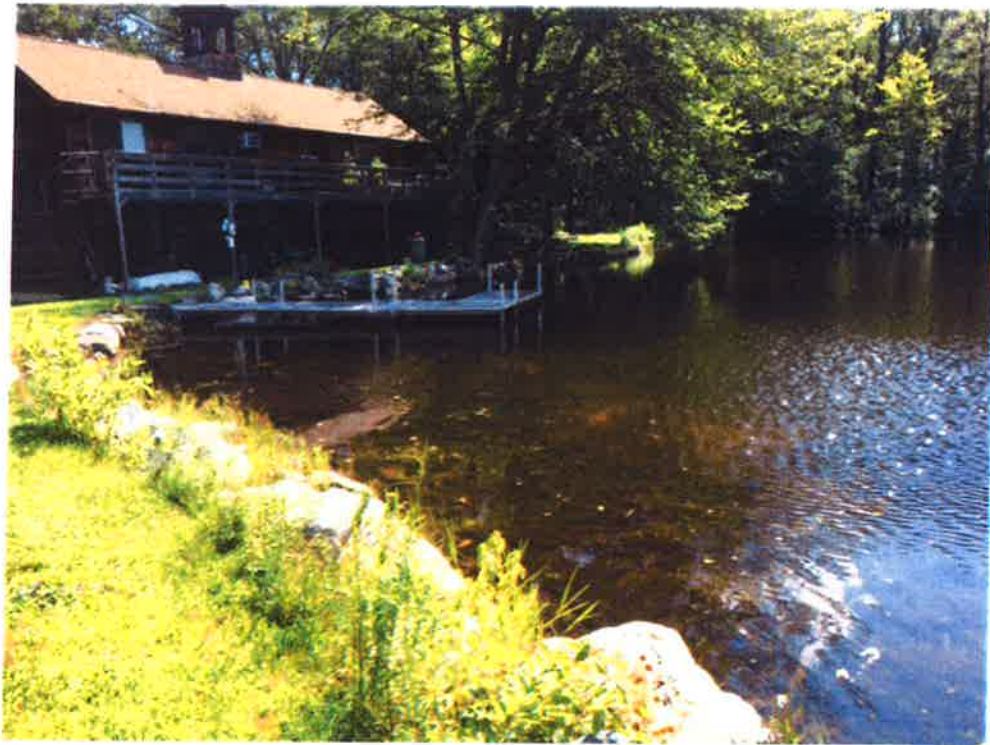
**Photo 1 Dam from left**

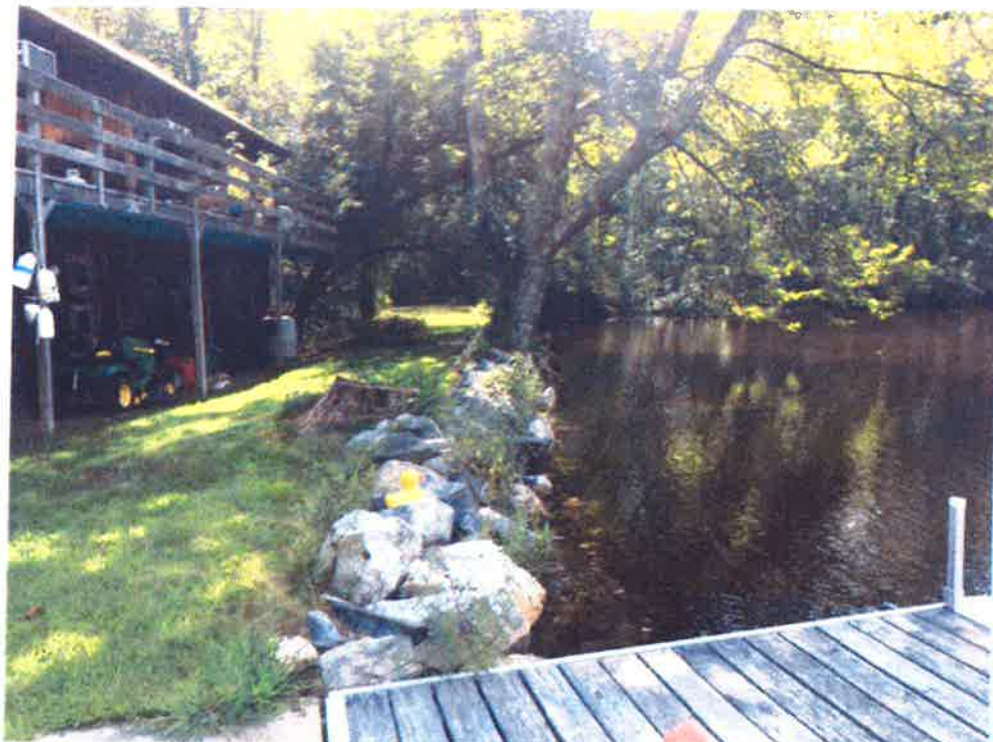
**Photo 2 Upstream face from left**

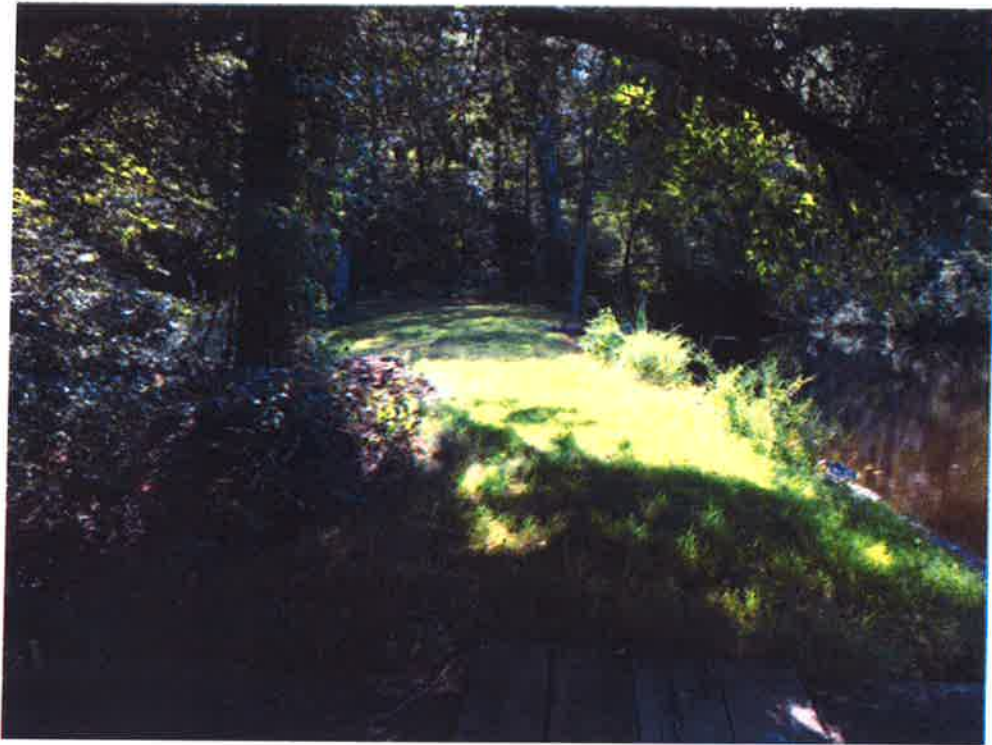
Riprap: Upstream **The left 2/3 has riprap. To the right of the property line there is no riprap and the embankment is slightly scarped or eroded at normal water level.**

**Photo 3 Right portion of embankment**

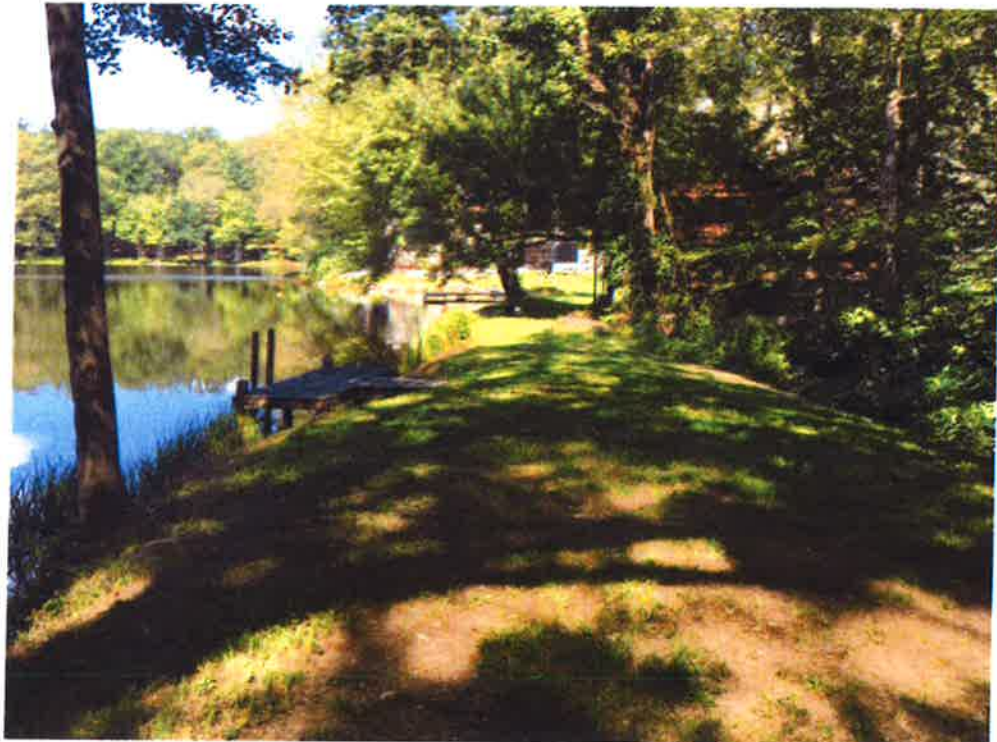
**Photo 4 Crest of embankment from right abutment**

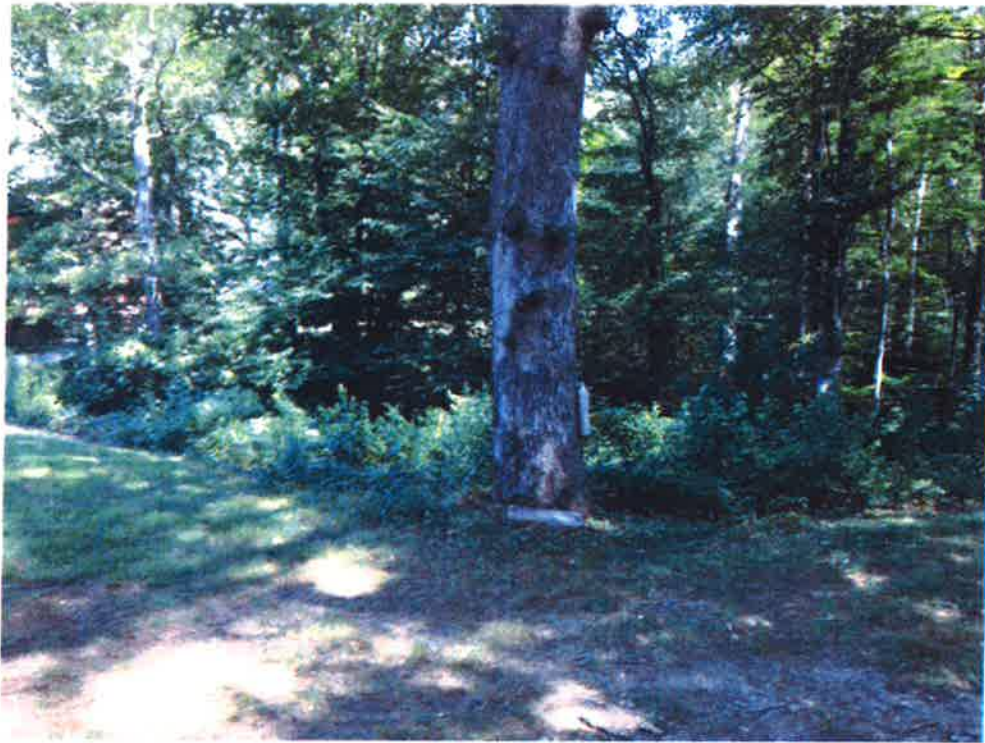
Other: **There are two large trees on the dam. To the left of the spillway there is a large maple at the upstream edge of the crest. On the right side there is a fairly large tree (Oak ?) at the downstream edge of the crest.**

**Photo 5 Large tree on downstream slope of right embankment**

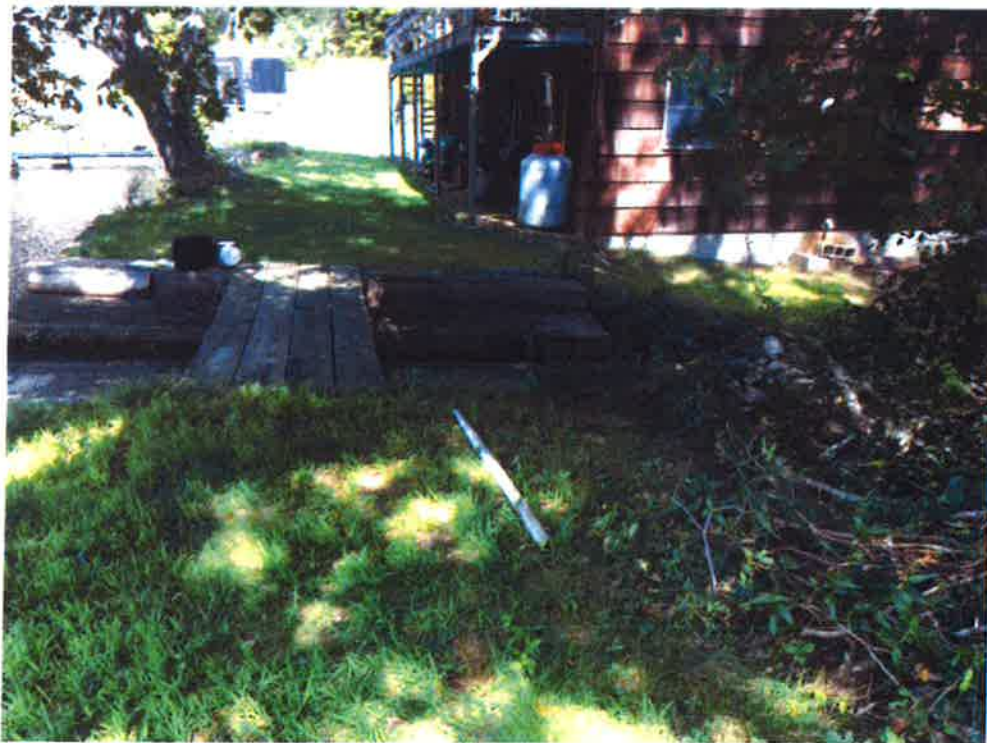
**Photo 6 Spillway from right**

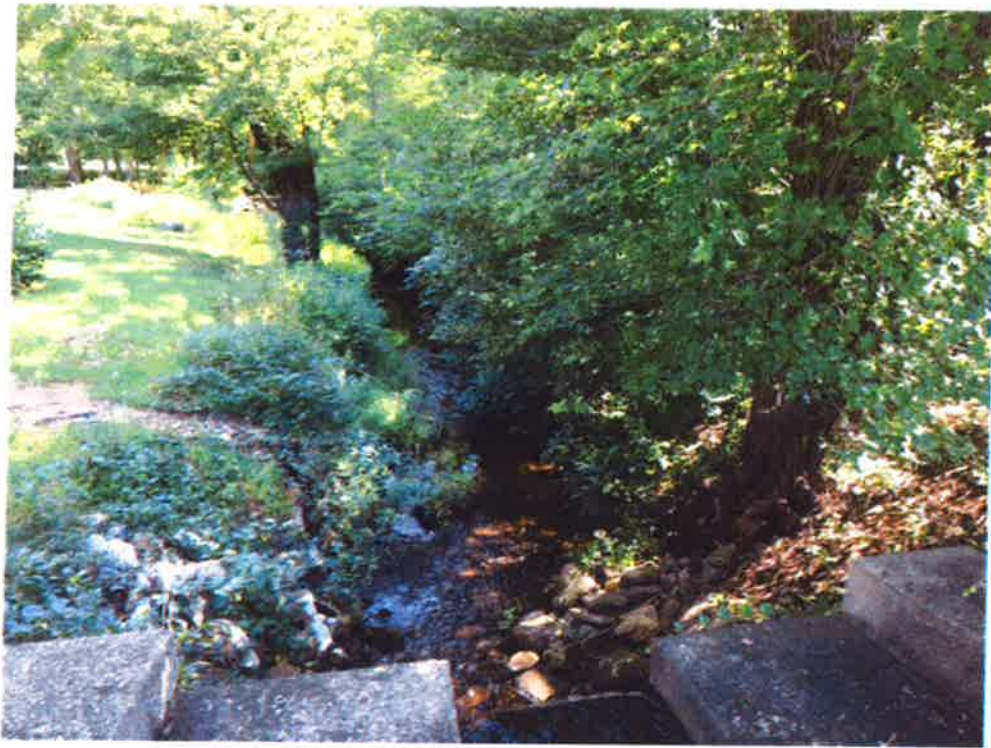
**Photo 7 Downstream channel**

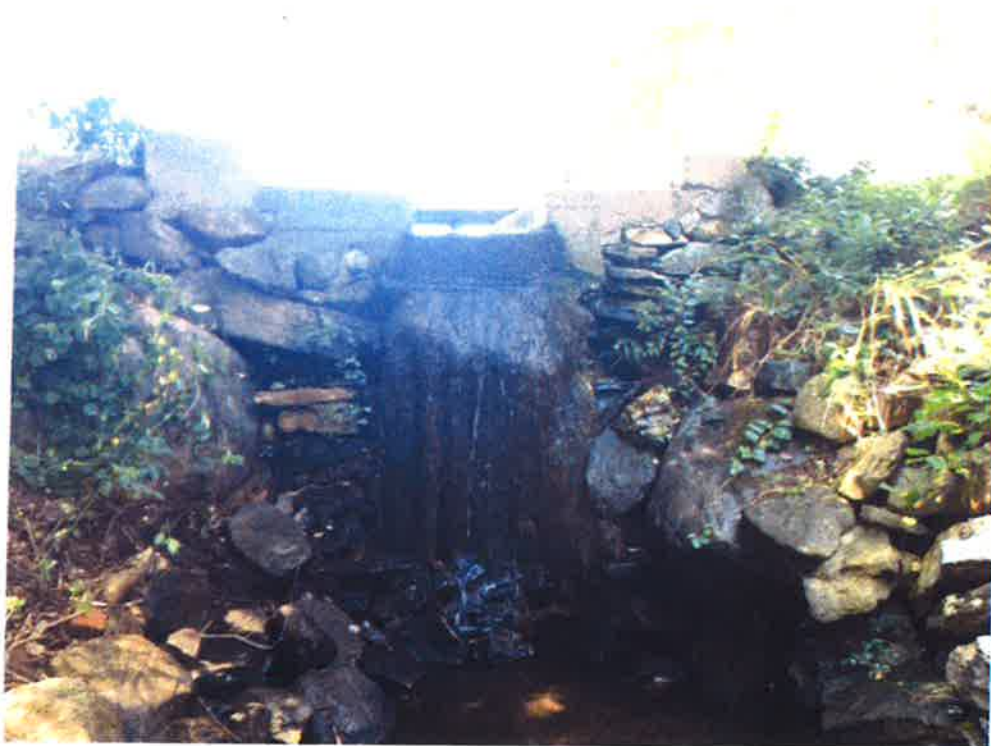
Stone Masonry: **The downstream face of spillway is a masonry wall with minor irregularities and several voids. There is a short section of masonry training wall immediately below the spillway on the left side of the channel that is missing some stones but appears stable at this time.**

Other: Previous reports had listed a non-functioning low level outlet; however no evidence was observable during the inspection. There is a square depression in the floor of the spillway that reportedly houses the control for a gate but nothing was discernable during the dam inspection. Due to water level during the inspection no upstream inlet was observable and the root mat under the spillway prevented observation of any outlet. (see photo 8)

**Photo 8 Downstream face of spillway**

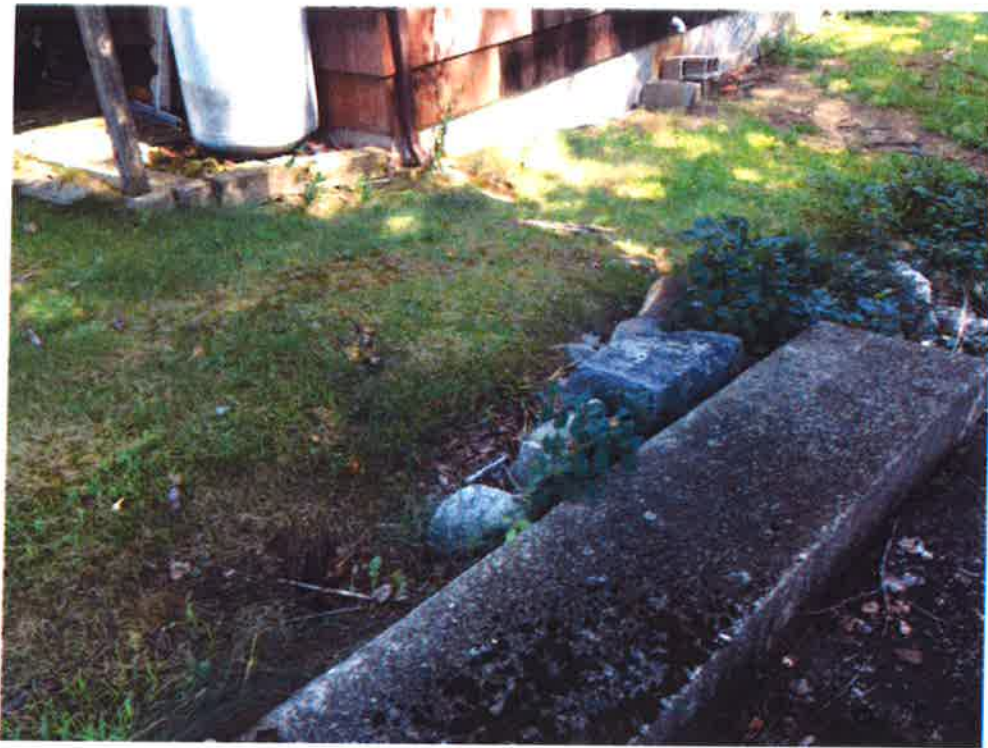
Erosion/Burrows: **There is evidence of minor past erosion immediately left of spillway.**

**Photo 9 Erosion on left side of spillway**

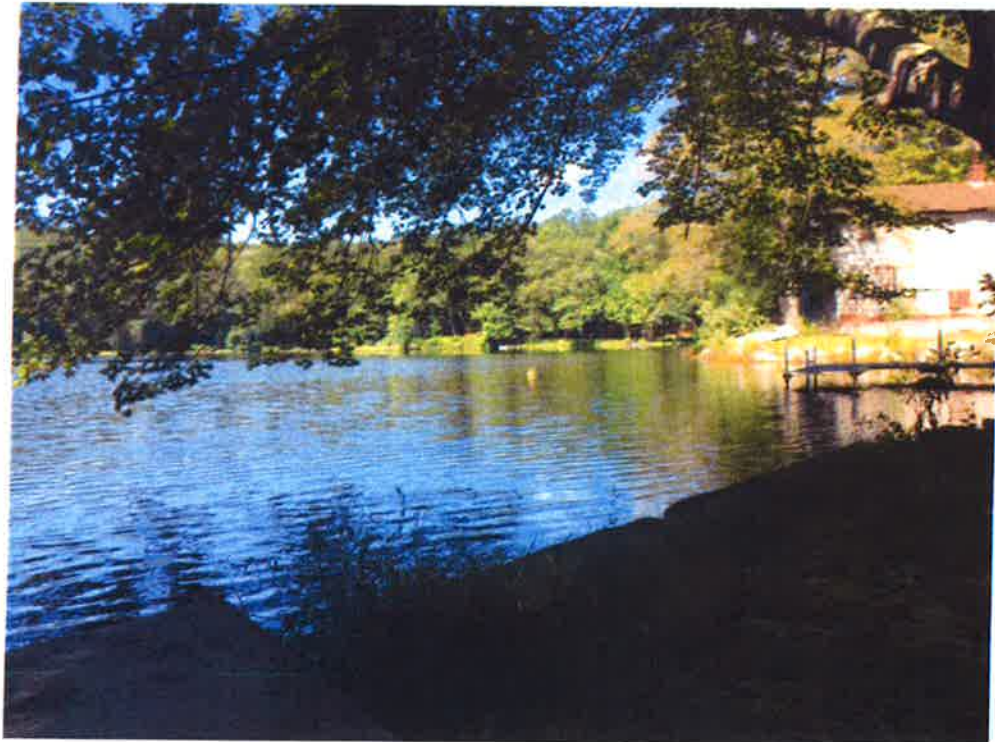
**Photo 10 Impoundment from Spillway**
