## **Dam Inspection Report**

**Birch Mill Pond Dam,  
Essex, CT  
Connecticut Dam Inventory No. 5004**

■ *August 25, 2017*

**Lenard Engineering, Inc.**  
Civil, Environmental & Hydrogeological Consultants

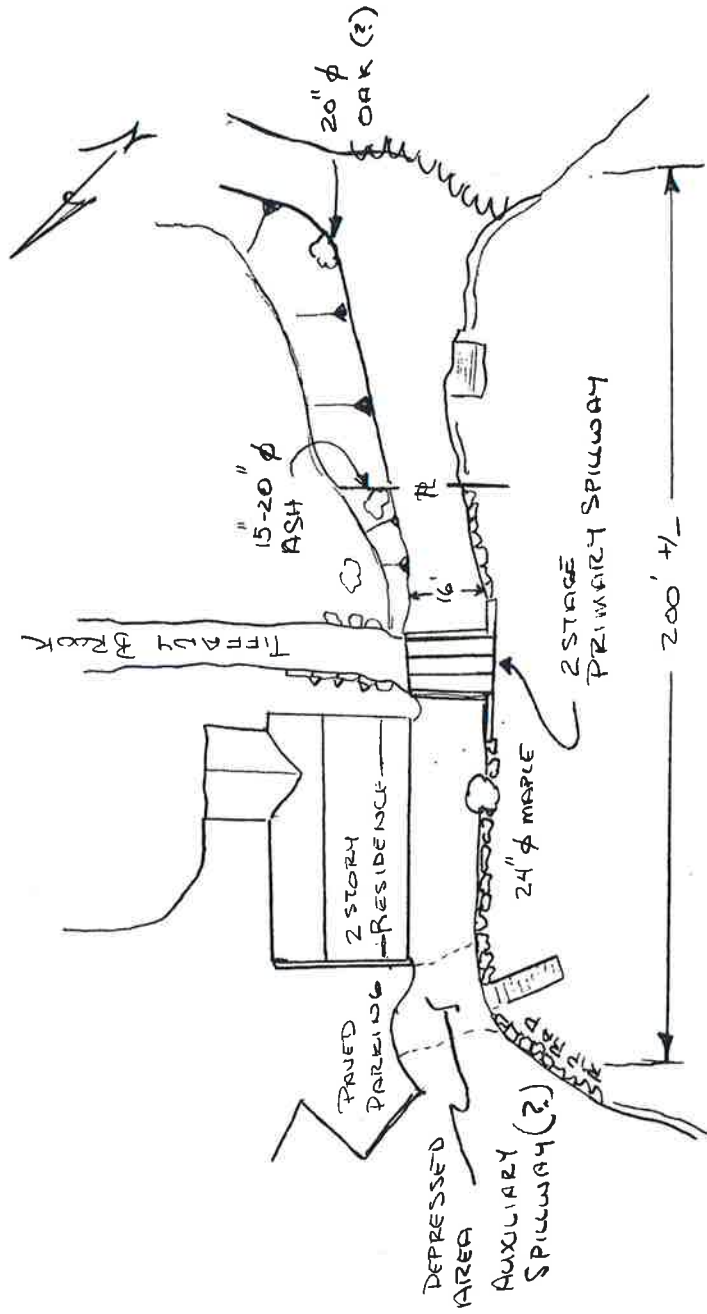
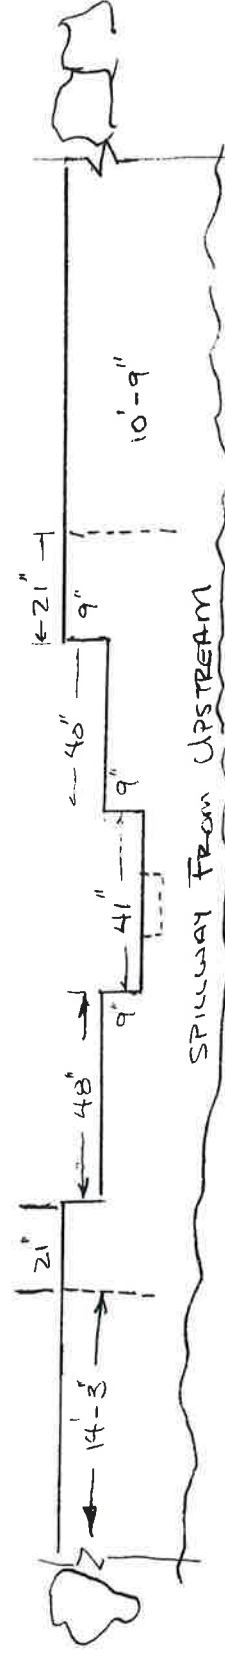
**SITE SKETCH**  
**BIRCH MILL POND DAM**  
**CT DAM #5004**  
**ESSEX, CT**

The dam and spillway are owned and maintained by three different entities or people. The spillway is owned by Southwinds Association, the embankment on the left side of the spillway and a short section on the right of the spillway are owned by Bruce and Jerrie MacMillian and the last 73 feet of the right embankment is owned by Rocco and Anna D'Amico. At the right termination of the upstream riprap, a capped metal pin, believed to be the property line, was observed (See sketch, pg 18 of 23).
